IRRIGATION SYSTEM OF VILCANCHOS

CONTRACT DATA

ELABORATION OF THE TECHNICAL FILES OF THE PROJECT "WATER INSTALLATION SERVICE OF THE WATER IRRIGATION SYSTEM OF VILCANCHOS, ESPITE, SAN JACINTO, SAN MIGUEL, DISTRICT OF VILCANCHOS – VICTOR FAJARDO – AYACUCHO"

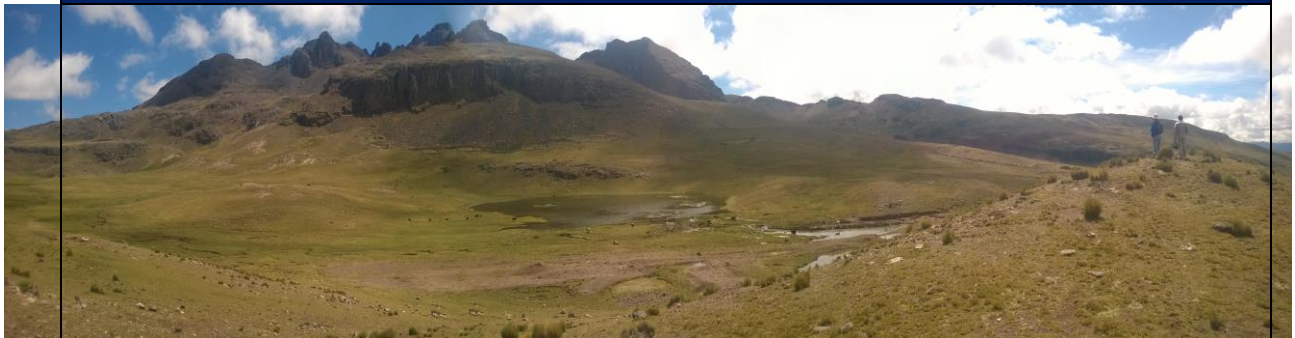
Photo of the lagoon to be dammed – Current State

PREVIOUS STATE
